# A/C Controllers Are Repairable!

By Ignacio "Nacho" Corella

**A/C SERVICE Tip—Fix The Controller, Don't Replace It!**

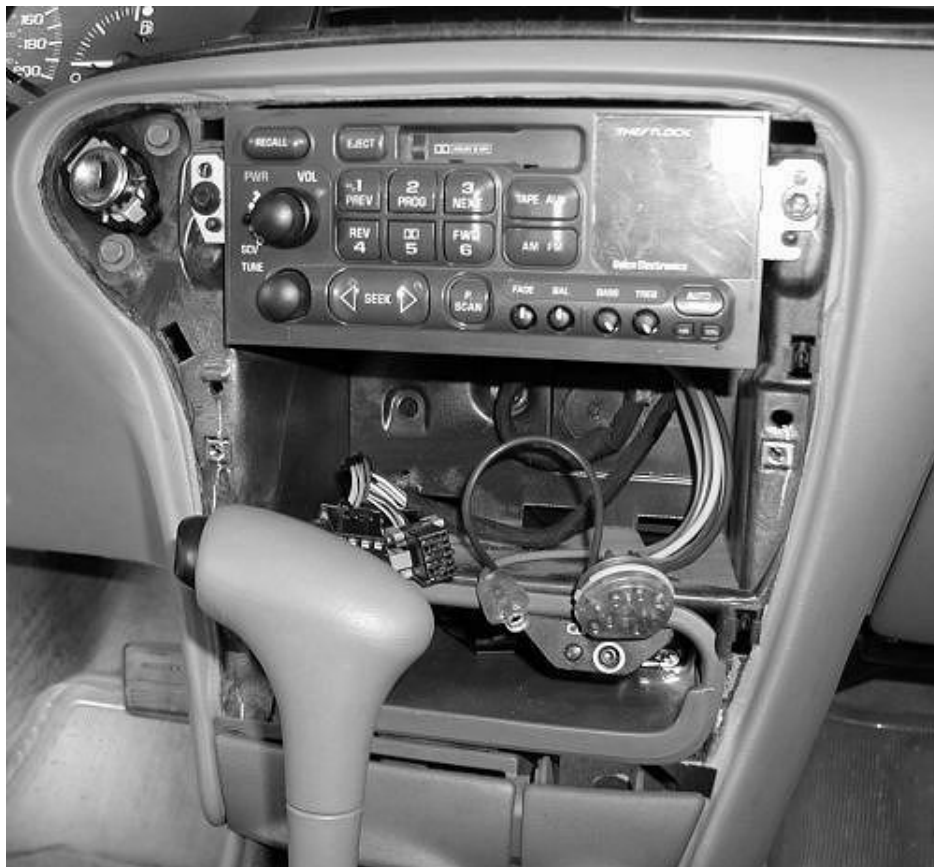
Above: Photo 1. 1997 Malibu panel with the Control Head and bezel removed.

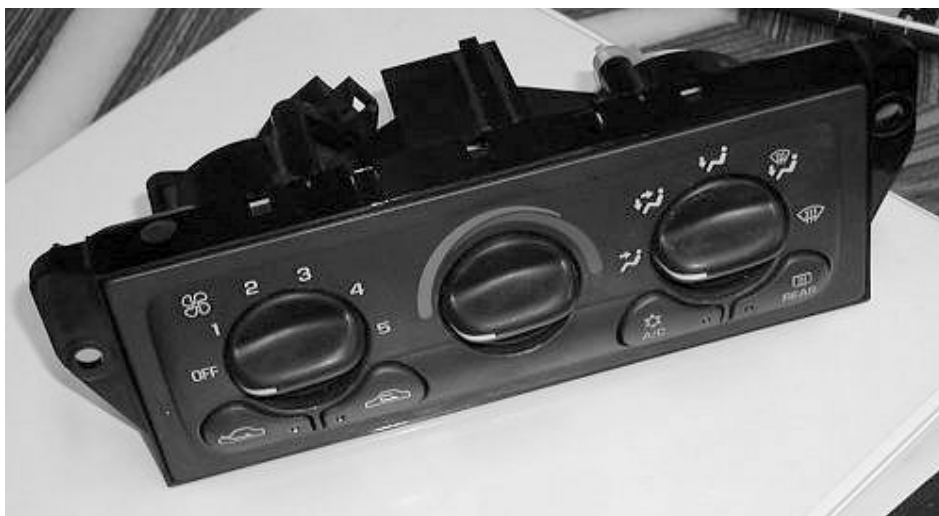
Above: Photo 2. Control Head removed. This unit is probably suffering from dirty contacts. With proper technique, this part can be restored to a servicable condition and live for several years.

The trick is to make sure that both the contacts and brushes make PERFECT

contact. The best way to accomplish that is by lifting the contacts and cleaning the PCB (Printed Circuit Board). We just use a small screwdriver as a lifting device. The PCB contacts and brushes are cleaned with a soft rag and alcohol, and dried with canned air. I do not suggest

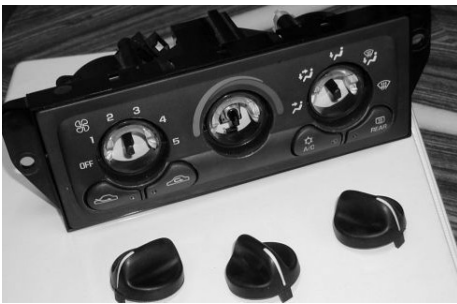
**Photo 3. Remove the knobs from the Control Head.**

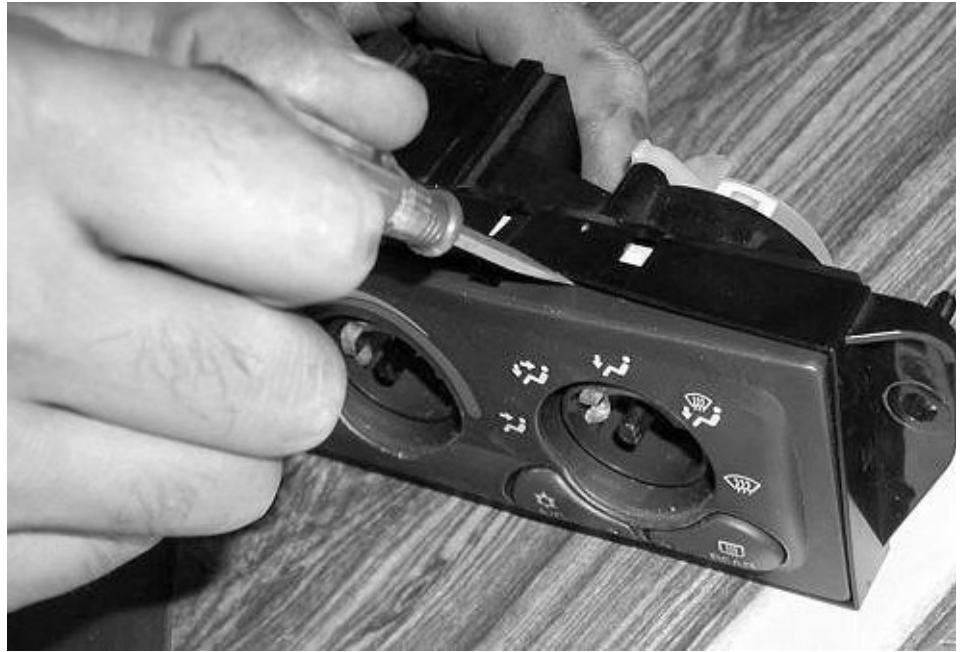
**Photo 4. Gently pry the face off of the Control head. Here we are using a small screw driver.**

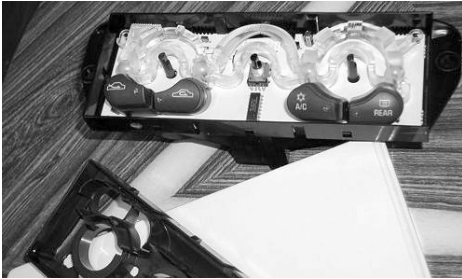
**Above: Photo 5. View beneath the Control Head face plate.**

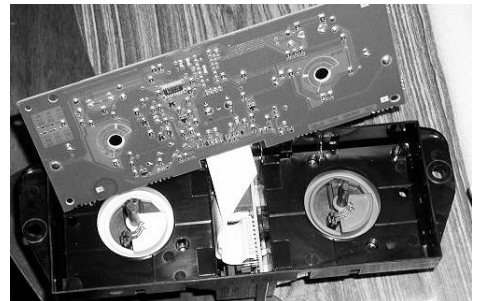
**Above: Photo 7. Loosen and slip out the Control Head's PCB (Printed Circuit Board).**
